INDOOR AIR QUALITY ASSESSMENT

**Franklin County Courthouse
425 Main Street
Greenfield, Massachusetts**

Prepared by:
Massachusetts Department of Public Health
Bureau of Environmental Health
Emergency Response/Indoor Air Quality Program
August 2007

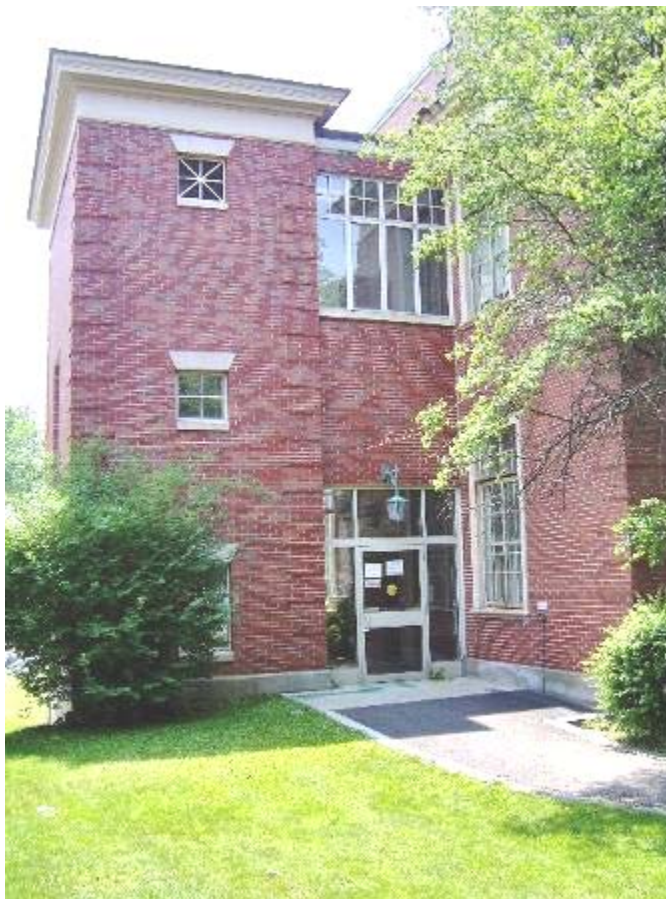
Picture 1

On June 8, 2007 a visit was made to the FCC by Michael Feeney, Director of BEH's Emergency Response/Indoor Air Quality (ER/IAQ), Program. The FCC is a red brick, three-story building built in 1931. The third floor contains the judge's chambers, the law library and the Franklin County Superior Court (SC). The second floor contains the Franklin County Family and Probate Court (FPC), Registry of Deeds, Clerk of Probate office, judge's lobby and offices. The ground floor contains the Greenfield District Court (DC), civil clerk's office, criminal clerk's office, judge's lobby, Franklin Regional Council of Governments office, lock-up and offices. Windows are openable throughout the building. An elevator was added to the eastern side of the building in the 1990s (Picture 1).

Elevator Added to East Wall of FCC

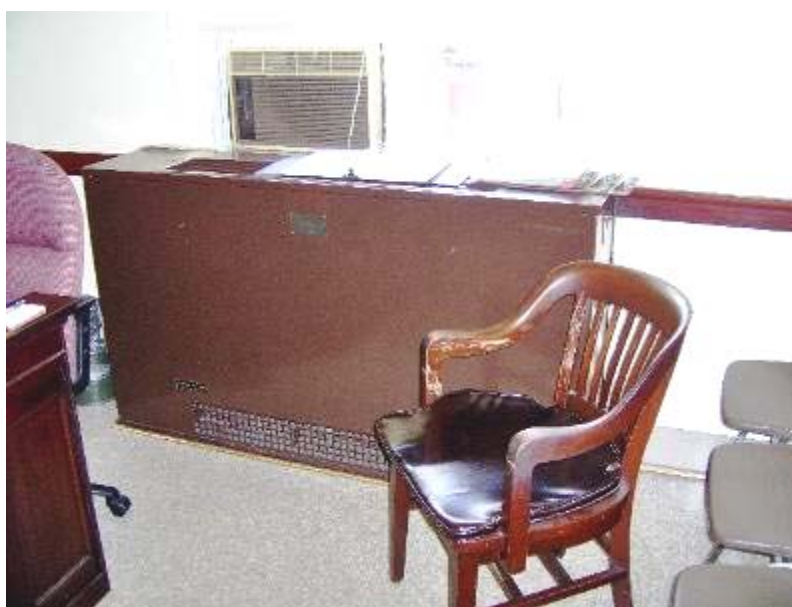
Picture 2

The building originally had fresh air supplied by unit ventilator (univent) systems ([Figure 1](#), Picture 2). Univents were found deactivated in all locations at the time of the assessment. A univent draws air from the outdoors through a fresh air intake located on the exterior wall of the building (Picture 3) and returns air through an air intake located at the base of the unit. Fresh and return air are mixed, filtered, heated and provided through an air diffuser located in the top of the unit. Adjustable louvers were set by hand to control the ratio of outside to recirculated air

1930's Vintage Univent

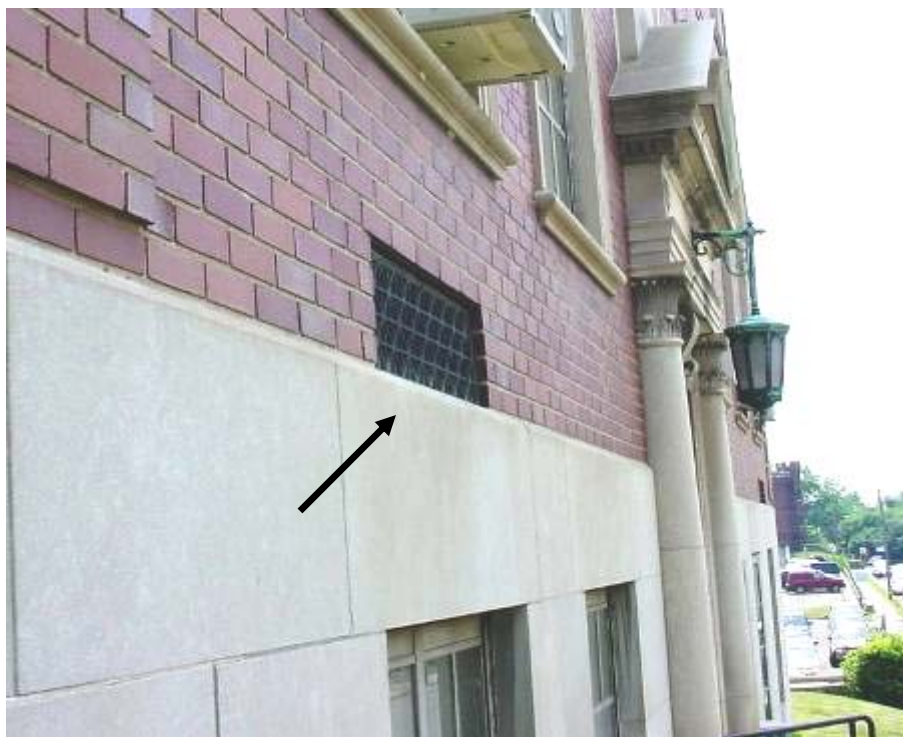
Picture 3

Univent Fresh Air Intake

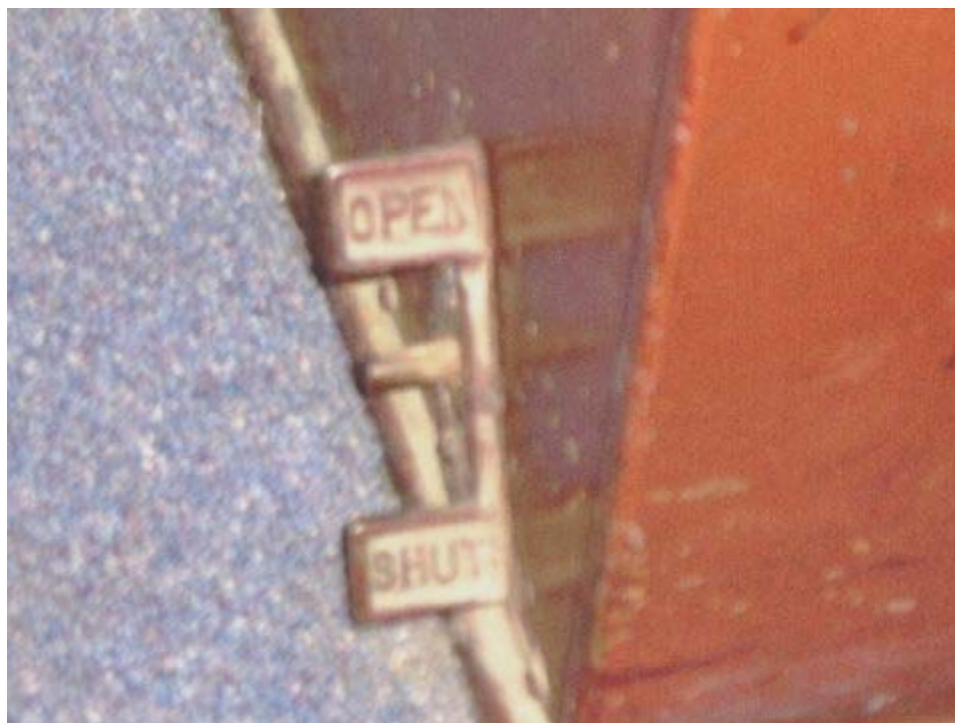
Picture 4

(Picture 4). The univents¹ appear to be original to the construction of the building (1931), which would make them over 75 years old. Replacement parts from the manufacturer are unlikely to be obtainable to repair this equipment. In addition, this type of univent is not likely to have a filtration system, which would allow for normally occurring outdoor pollutants (e.g., pollen/dusts) to readily enter the building via the univents.

Univent Louver Control

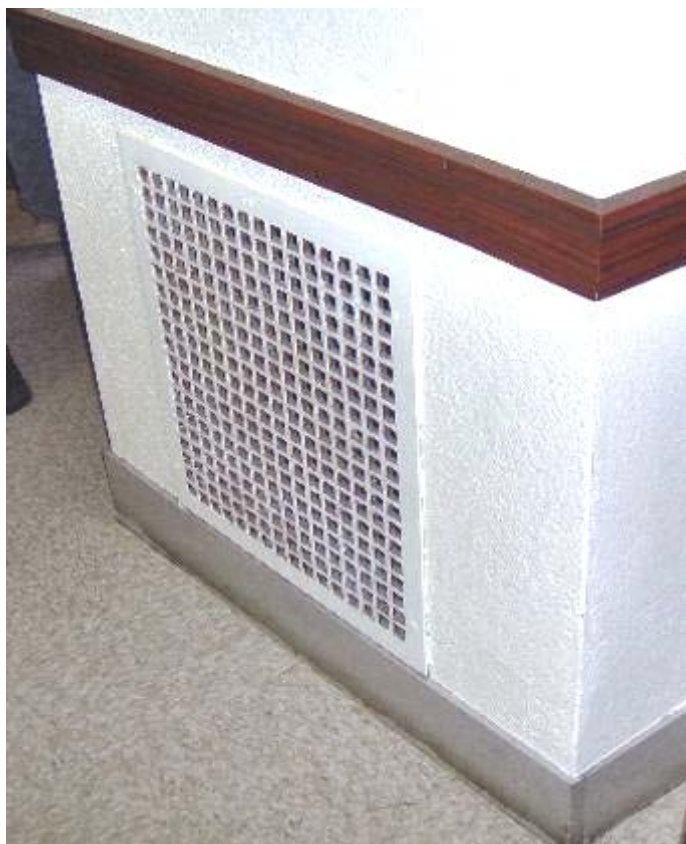
Picture 5

Mechanical exhaust ventilation was originally provided by wall-mounted vents (Picture 5) ducted to rooftop motors. Airflow was controlled by adjusting louvers by hand (Picture 6). FCC staff reported that rooftop exhaust motors were inoperable. It appears that an exhaust fan was installed in the holding cell to remove odors. While a transfer vents exist to allow for the draw of air (Picture 7), carbon dioxide measurements in the holding cell indicate minimal air exchange in this area. Without proper supply and exhaust ventilation normally occurring environmental pollutants can build up indoors and lead to IAQ/comfort complaints.

Exhaust Vent

5. Ascertain if the exhaust ventilation system can be repaired. Examine the feasibility of repairing the motors to the original exhaust ventilation system and opening the exhaust vent ducts and hallway doors to create airflow.

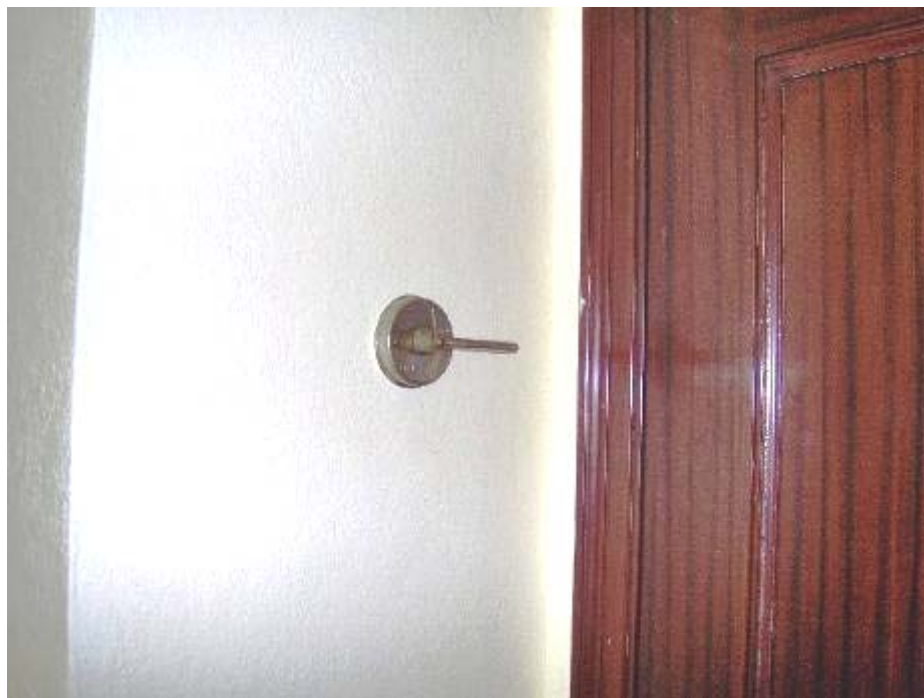
Picture 6

Exhaust Vent Louver Control

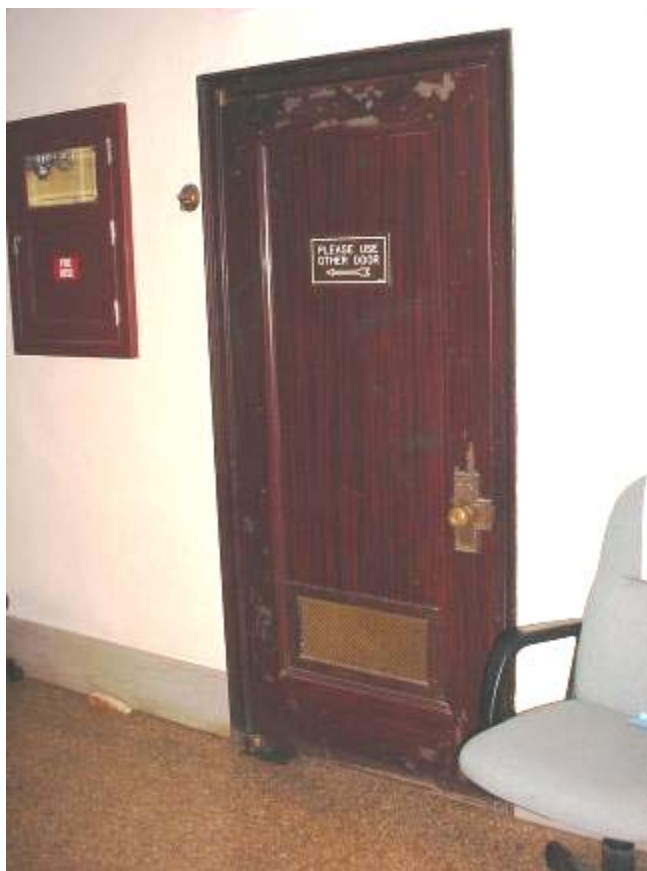
Picture 7

Lock-Up Transfer Air Vent (Bottom of Door)

6. Examine the lockup and restroom exhaust vents. Repair is needed to maximize the air drawn by these vents.

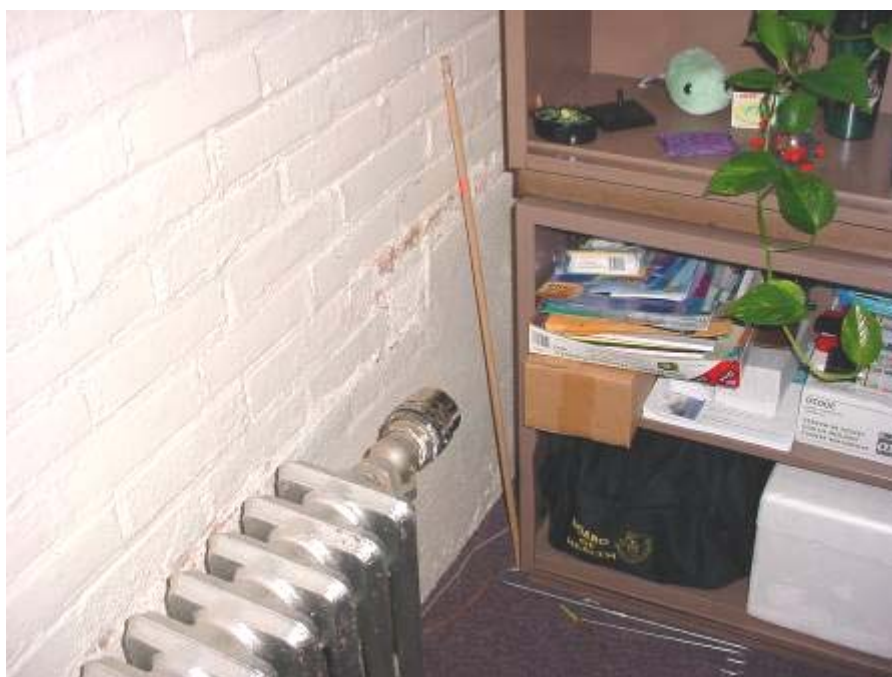
Picture 8

The FCC has a history of water penetration problems, particularly in the crawlspace along the front of the building. Upon entering room 11, a musty odor was detected. Efflorescence (i.e., mineral deposits) and peeling paint was observed on the brickwork of exterior walls in room 11 (Picture 8). Efflorescence is a characteristic sign of water intrusion. As moisture penetrates and works its way through mortar around brick, stone or cementitious material it leaves behind these characteristic mineral deposits. The likely source of the moisture is rainwater accumulation against the foundation, seeping through cracks and crevices in the tarmac apron along the foundation of the north and west walls (Pictures 9 through 11). Of note is a large space between the apron and the foundation, which roughly corresponds to the efflorescence in room 11 (Picture 11).

Efflorescence in Room 11

2. Carpet and coving along all exterior walls in offices on the ground floor at the front (north wall) of the building should be removed. Carpeting should be removed in a manner consistent with recommendations in “Mold Remediation in Schools and Commercial Buildings” published by the US Environmental Protection Agency (US EPA, 2001). This document is available from the US EPA website: http://www.epa.gov/iaq/molds/mold_remediation.html. Replace with a non-porous material (e.g., non-slip tile).

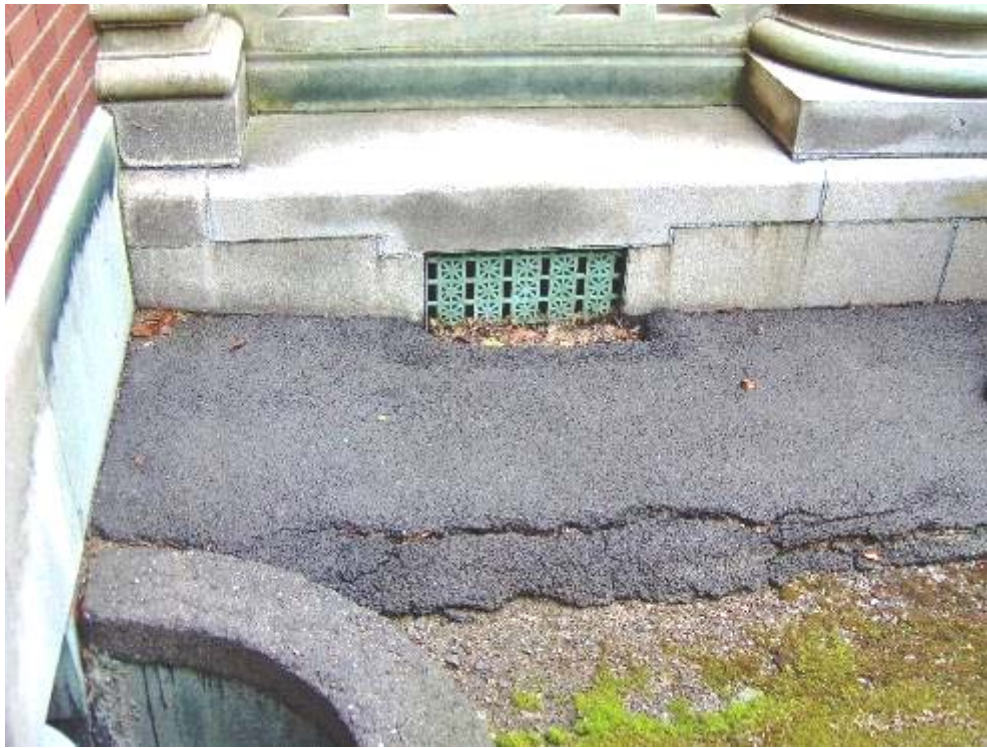
Picture 9

Cracks in Apron, North Wall of Building

1. Repair the tarmac apron around the edge of the foundation. Remove plants from the exterior wall/apron junction and seal with an appropriate material.

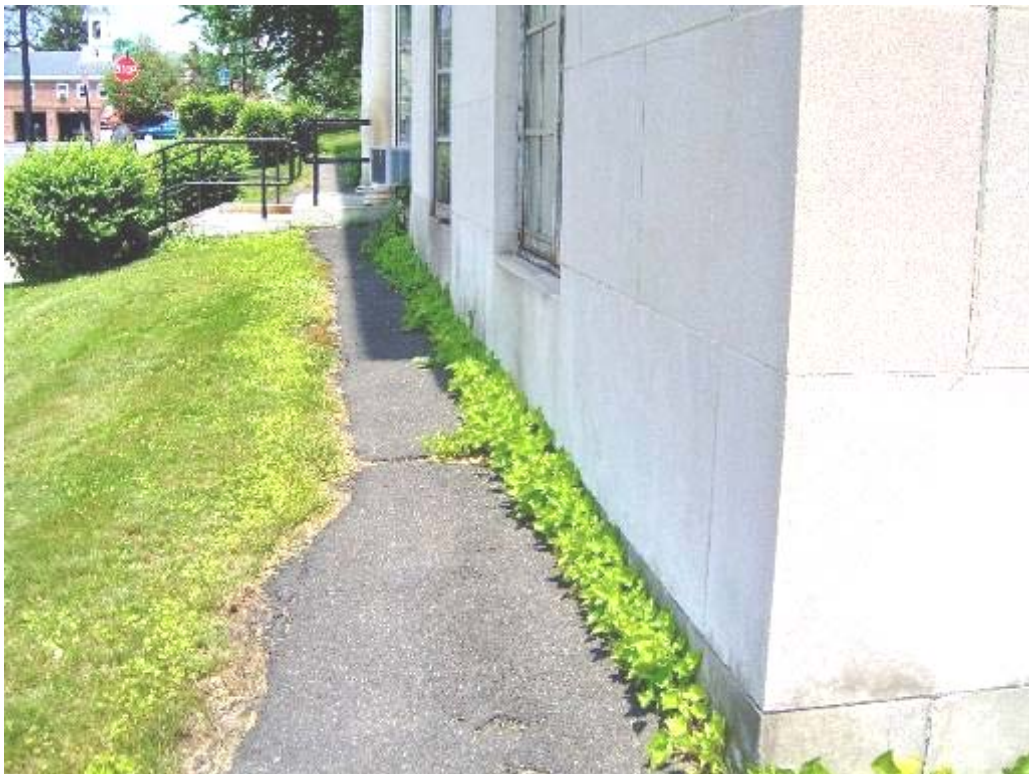
Picture 10

Cracks in Apron and Plants in Apron/Wall Junction, West Wall of Building

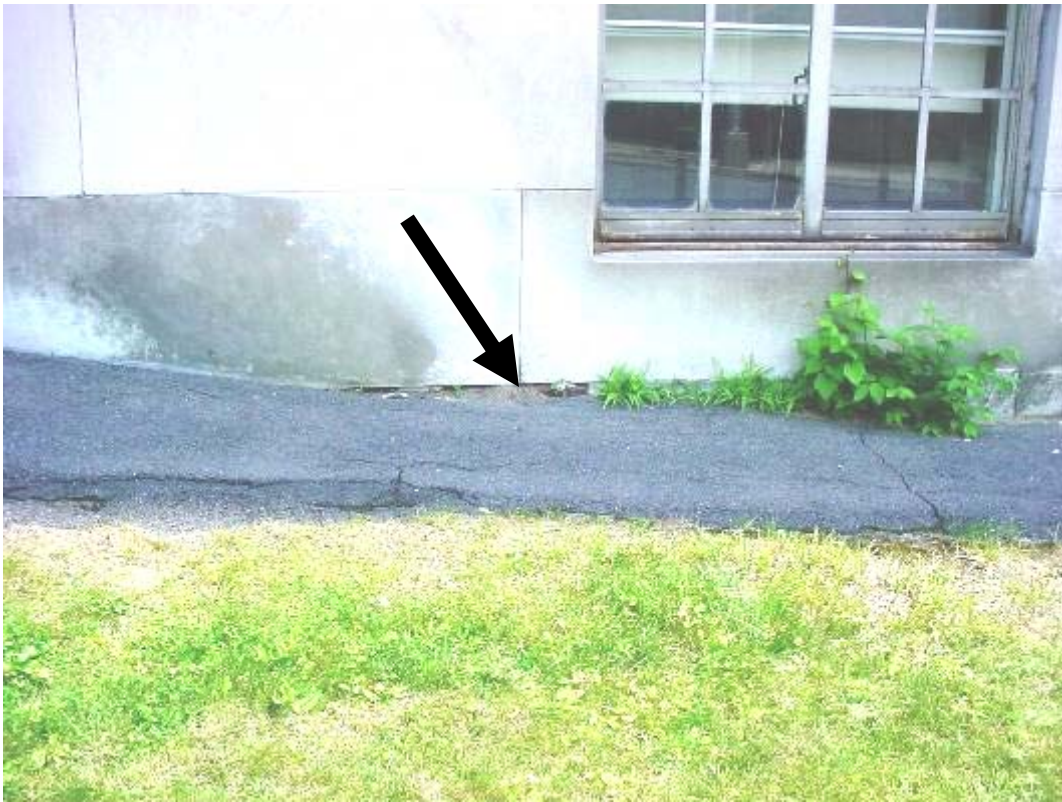
Picture 11

Cracks in Apron Exposing Foundation of Room 11 Window, West Wall of Building

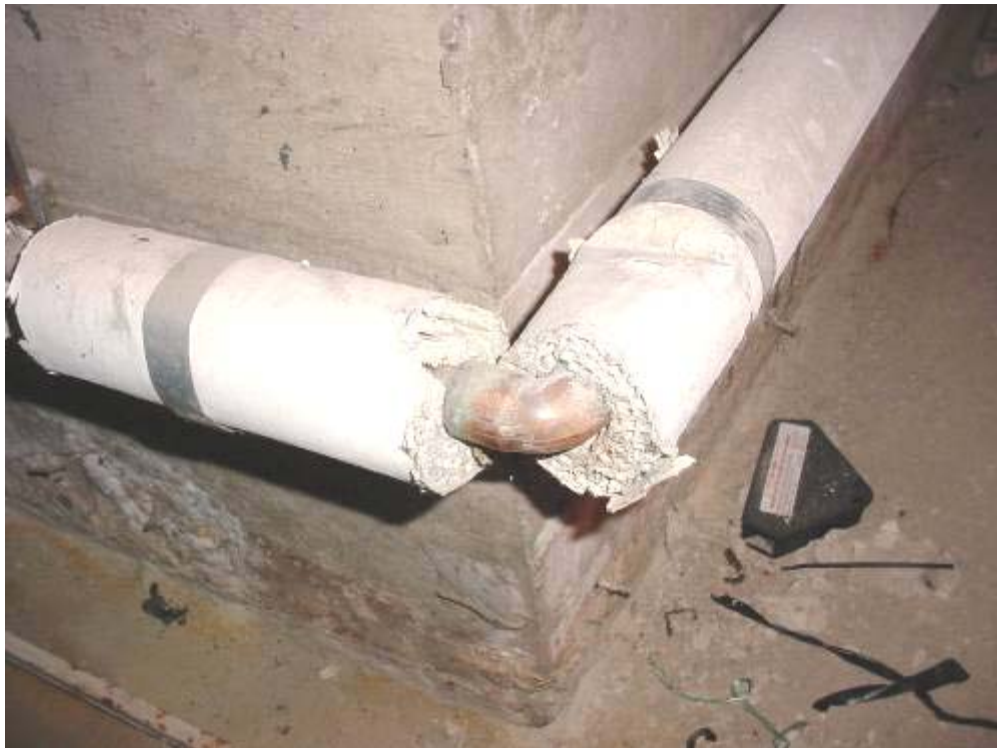
Picture 12

A number of other conditions that can affect indoor air quality were noted during the assessment. An open pipe with insulation that consists of a white, powdered material was found in the crawlspace (Picture 12). The material may contain asbestos and should be remediated in conformance with all applicable Massachusetts asbestos abatement and hazardous materials disposal laws. Concerns were raised regarding asbestos and wall materials. The interior walls of the FCC appear to be horsehair plaster built over walls constructed of terra cotta (Picture 13). In the early part of the 1900's asbestos was commonly mixed into plaster as a replacement for horsehair. However, this material would not pose an exposure and related health risk if left intact.

Insulation on Pipes in Crawlspace

7. Remediate exposed pipe insulation in crawlspace in conformance with Massachusetts asbestos remediation and hazardous waste disposal laws.
8. Have a sample of the plaster tested for asbestos content. If it contains asbestos, remediate plaster in a manner consistent with asbestos remediation laws and regulations and maintain intact plaster to prevent friability of asbestos.
9. Ensure plants have drip pans. Examine drip pans periodically for mold growth and disinfect with an appropriate antimicrobial where necessary. Do not store on porous materials.

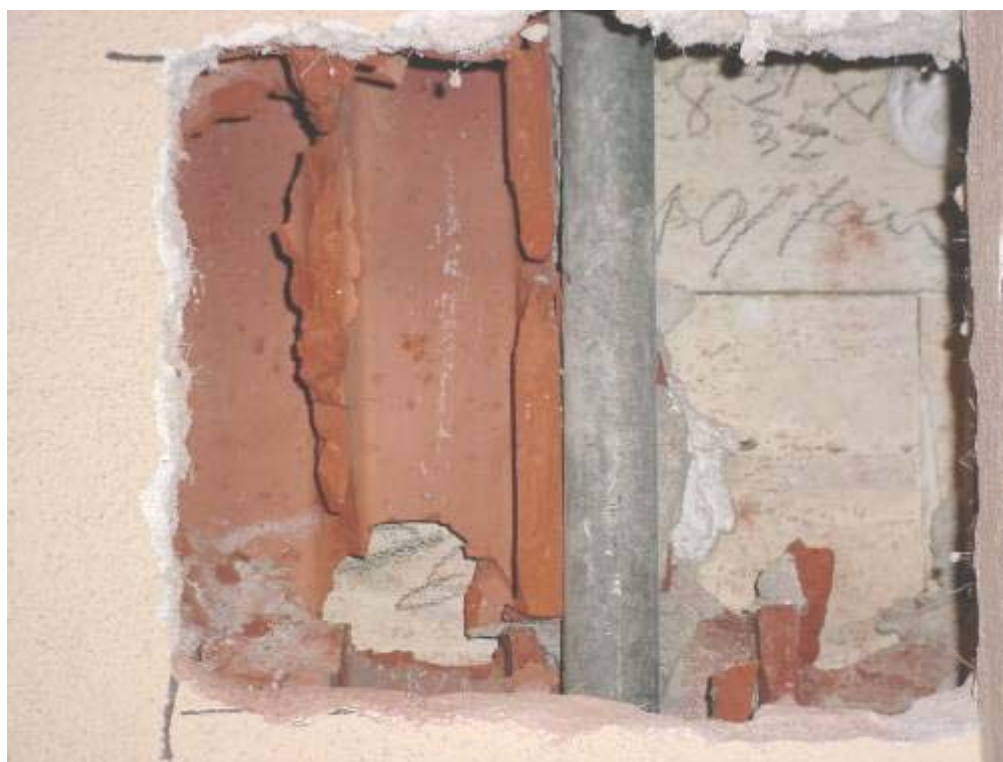
Picture 13

Hole in Wall, First Floor, Note Terracotta
